PIC18F2410/2510/4410/4510 Rev. B3 Silicon Errata

The PIC18F2410/2510/4410/4510 Rev. B3 parts you have received conform functionally to the Device Data Sheet (DS39636D), except for the anomalies described below. Any Data Sheet Clarification issues related to the PIC18F2410/2510/4410/4510 will be reported in a separate Data Sheet errata. Please check the Microchip web site for any existing issues.

The following silicon errata apply only to PIC18F2410/2510/4410/4510 devices with these Device/Revision IDs:

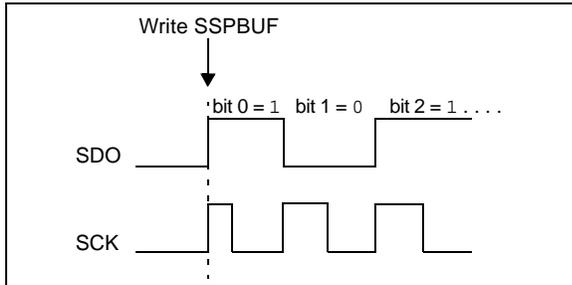
FIGURE 1: SCK PULSE VARIATION USING TIMER2/2

2. Module: MSSP (SPI Mode)

When the SPI is using Timer2/2 as the clock source, a shorter than expected SCK pulse may occur on the first bit of the transmitted/received data (Figure 1).

To avoid producing the short pulse, turn off Timer2 and clear the TMR2 register, load the SSPBUF with the data to transmit and then turn Timer2 back on. Refer to [Example 1](#) for sample code.
