# PIC32MZ EF FAMILY

## PIC32MZ Embedded Connectivity with Floating Point Unit (EF) Family Silicon Errata and Data Sheet Clarification

The PIC32MZ Embedded Connectivity with Floating Point Unit (EF) family of devices that you have received conform functionally to the current Device Data Sheet (DS60001320D), except for the anomalies described in this document.

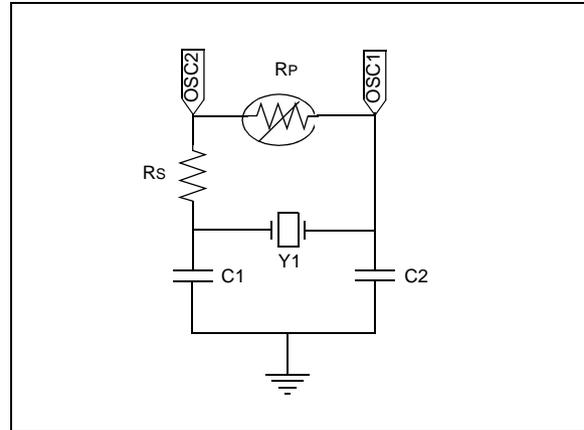
**FIGURE 1: POSC CRYSTAL CIRCUIT**

**Revision A1 Silicon:** A crystal oscillator cannot be used as an input to the Primary Oscillator (Posc) pins OSC1 and OSC2.

**Revision A3 Silicon:** The Posc has been tested in a normal power-up sequence and supports specific crystal operation.

The Primary Oscillator (Posc) has been characterized to operate at 8 MHz, 12 MHz, and 24 MHz when the circuit in [Figure 1](#) is implemented, and the operating conditions listed in [Table 3](#) are met.

Crystal Frequency (see Note 1)	Series Resistor (Rs)	Posc Gain Setting POSCGAIN<1:0> (DEVCFG0<20:19>)	Posc Boost Setting POSCBOOST (DEVCFG0<21>)
8 MHz	2 kΩ	'0b00 (GAIN_0)	'0b1 (ON)
12 MHz	1 kΩ	'0b00 (GAIN_0)	'0b1 (ON)
24 MHz	0 kΩ	'0b00 (GAIN_0)	'0b1 (ON)

- Note 1:** Using any other crystal frequency will require special component selection and characterization.  
**Note 2:** A parallel resistor (Rp) should not be used to increase the gain of the POSC.
