STM32L476xx/STM32L486xx device limitations

Silicon identification

This errata sheet applies to revisions '3' and '4' of the STMicroelectronics STM32L476xx and STM32L486xx products. The STM32L4x6xx family features an ARM® 32-bit Cortex®-M4 core.

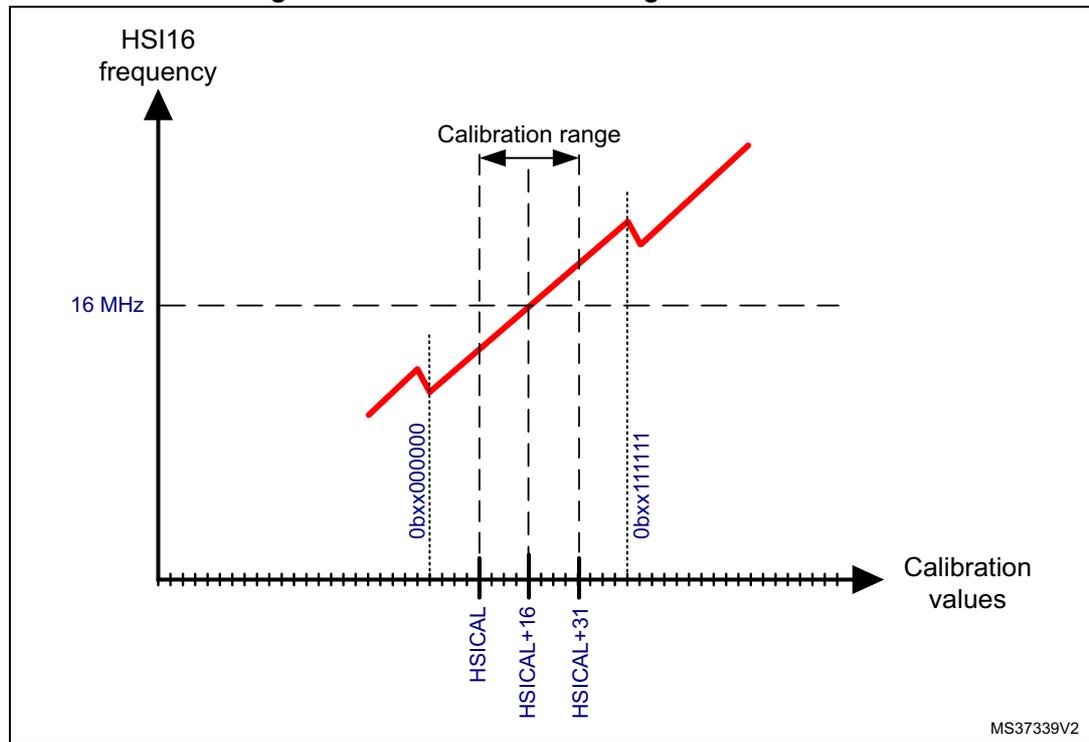
Figure 1. HSI oscillator trimming characteristics

Consequently, the user trim correction must not jump over the codes multiple of 64, which can limit the user correction either in positive or in negative direction.

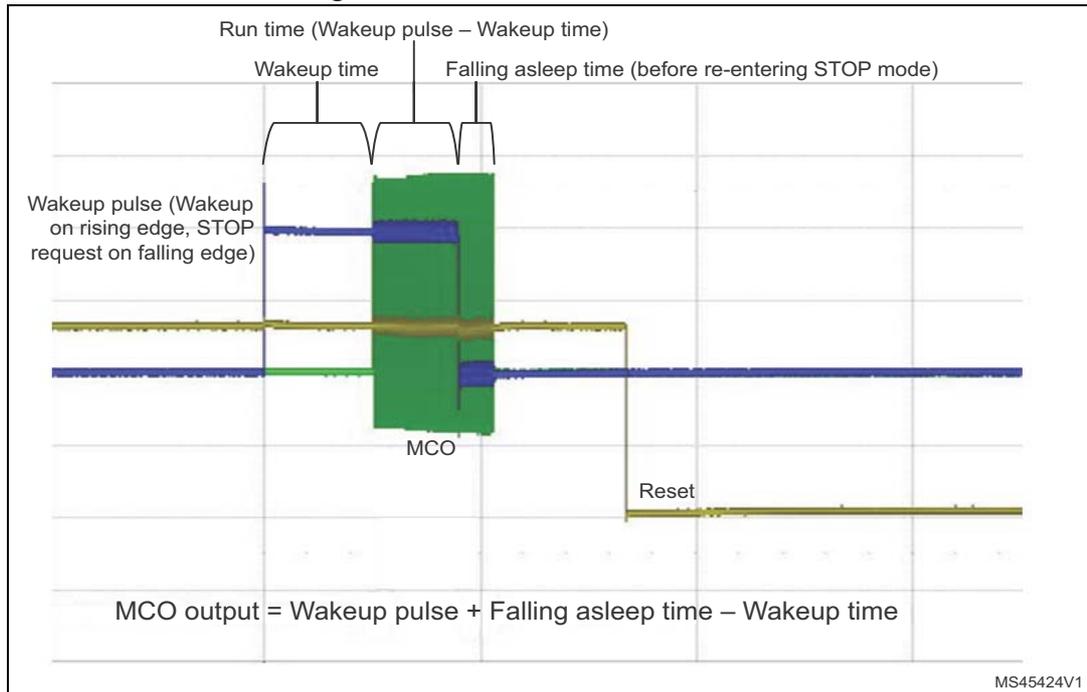
Figure 2. Minimum Run time definition

The minimum Run time defined in [Table 5](#) corresponds to the firmware execution time on the core. Note also that, as shown in [Figure 2](#), the length of the MCO output (green trace) is longer than the firmware execution time.

Ensure that the Run time between two Stop sequences is long enough to avoid the generation of a Brown Out Reset.

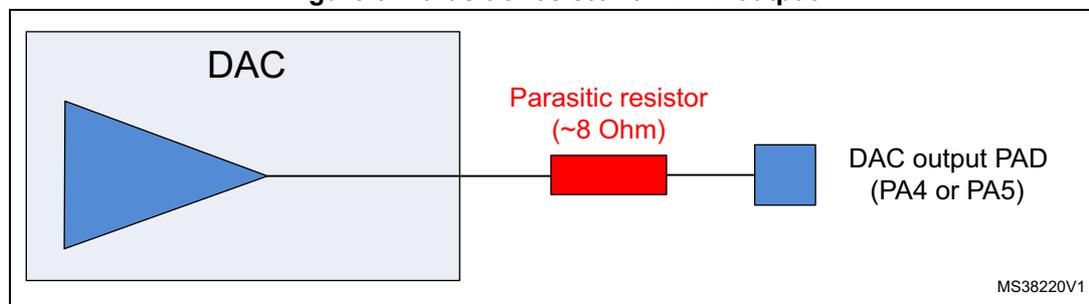
Figure 3. Parasitic resistor on DAC output

2.15.4 DAC characteristics can be degraded depending on the current sunk on DAC output

Resistor value between DAC outputs and I/O (PA4 or PA5) is greater than expected: 8ohm typical, as shown in *Figure 3*. As a consequence the DAC characteristics can be impacted depending on the current sunk on DAC output.

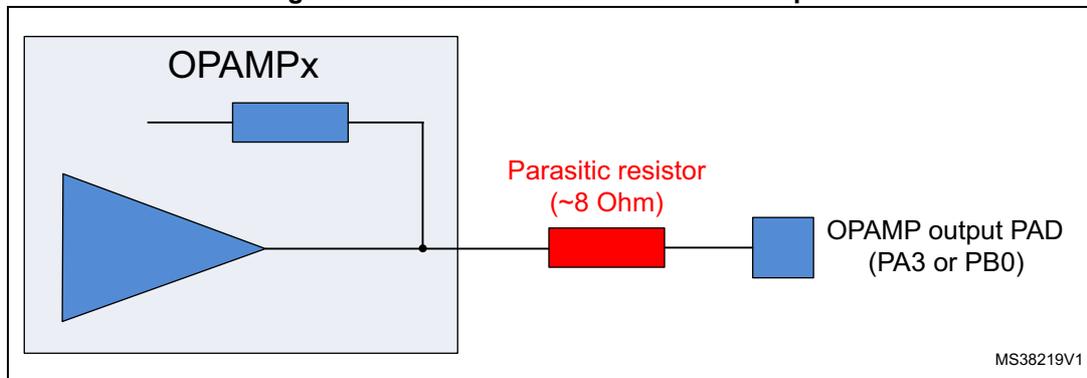
Figure 4. Parasitic resistor on OPAMP output

2.16.1 OPAMP characteristics can be degraded depending on the current sunk on OPAMP output

Resistor value between OPAMP outputs and I/O (PA3 or PB0) is greater than expected: 8 ohm typical, as shown in [Figure 4](#). As a consequence the OPAMP characteristics can be impacted depending on the current sunk on the output.
