PIC18F45J10 Family Silicon Errata and Data Sheet Clarification

The PIC18F45J10 family devices that you have received conform functionally to the current Device Data Sheet (DS39682E), except for the anomalies described in this document.

PIC18F45J10 FAMILY

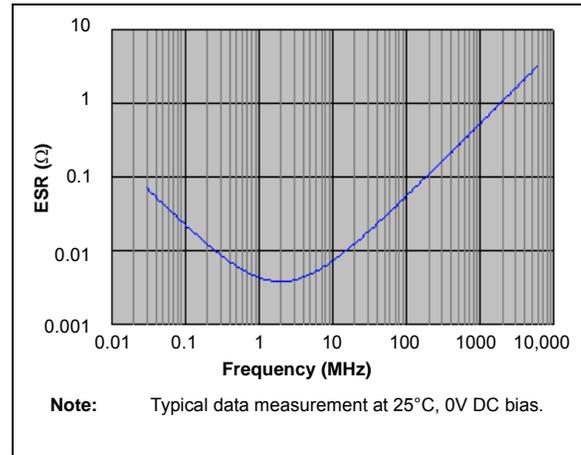
FIGURE 2-3 FREQUENCY vs. ESR PERFORMANCE FOR SUGGESTED VCAP

When the regulator is enabled (F devices), a low-ESR (< 5Ω) capacitor is required on the VCAP/VDDCORE pin to stabilize the voltage regulator output voltage. The VCAP/VDDCORE pin must not be connected to VDD and must use a capacitor of 10 μF connected to ground. The type can be ceramic or tantalum. Suitable examples of capacitors are shown in [Table 2-1](#). Capacitors with equivalent specifications can be used.

Designers may use [Figure 2-3](#) to evaluate ESR equivalence of candidate devices.

It is recommended that the trace length not exceed 0.25 inch (6 mm). Refer to [Section 24.0 “Electrical Characteristics”](#) for additional information.

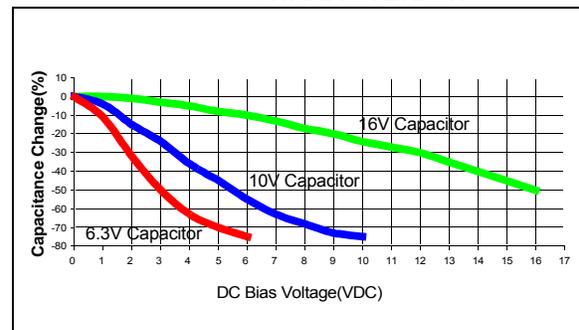
FIGURE 2-4 DC BIAS VOLTAGE vs. CAPACITANCE CHARACTERISTICS

In addition to temperature tolerance, the effective capacitance of large value ceramic capacitors can vary substantially, based on the amount of DC voltage applied to the capacitor. This effect can be very significant, but is often overlooked or is not always documented.

A typical DC bias voltage vs. capacitance graph for 16V, 10V and 6.3V rated capacitors is shown in Figure 2-4.

When selecting a ceramic capacitor to be used with the internal voltage regulator, it is suggested to select a high-voltage rating, so that the operating voltage is a small percentage of the maximum rated capacitor voltage. For example, choose a ceramic capacitor rated at 16V for the 2.5V core voltage. Suggested capacitors are shown in Table 2-1.
