dsPIC33EPXXXGS70X/80X Family Silicon Errata and Data Sheet Clarification

The dsPIC33EPXXXGS70X/80X family devices that you have received conform functionally to the current Device Data Sheet (DS70005258B), except for the anomalies described in this document.

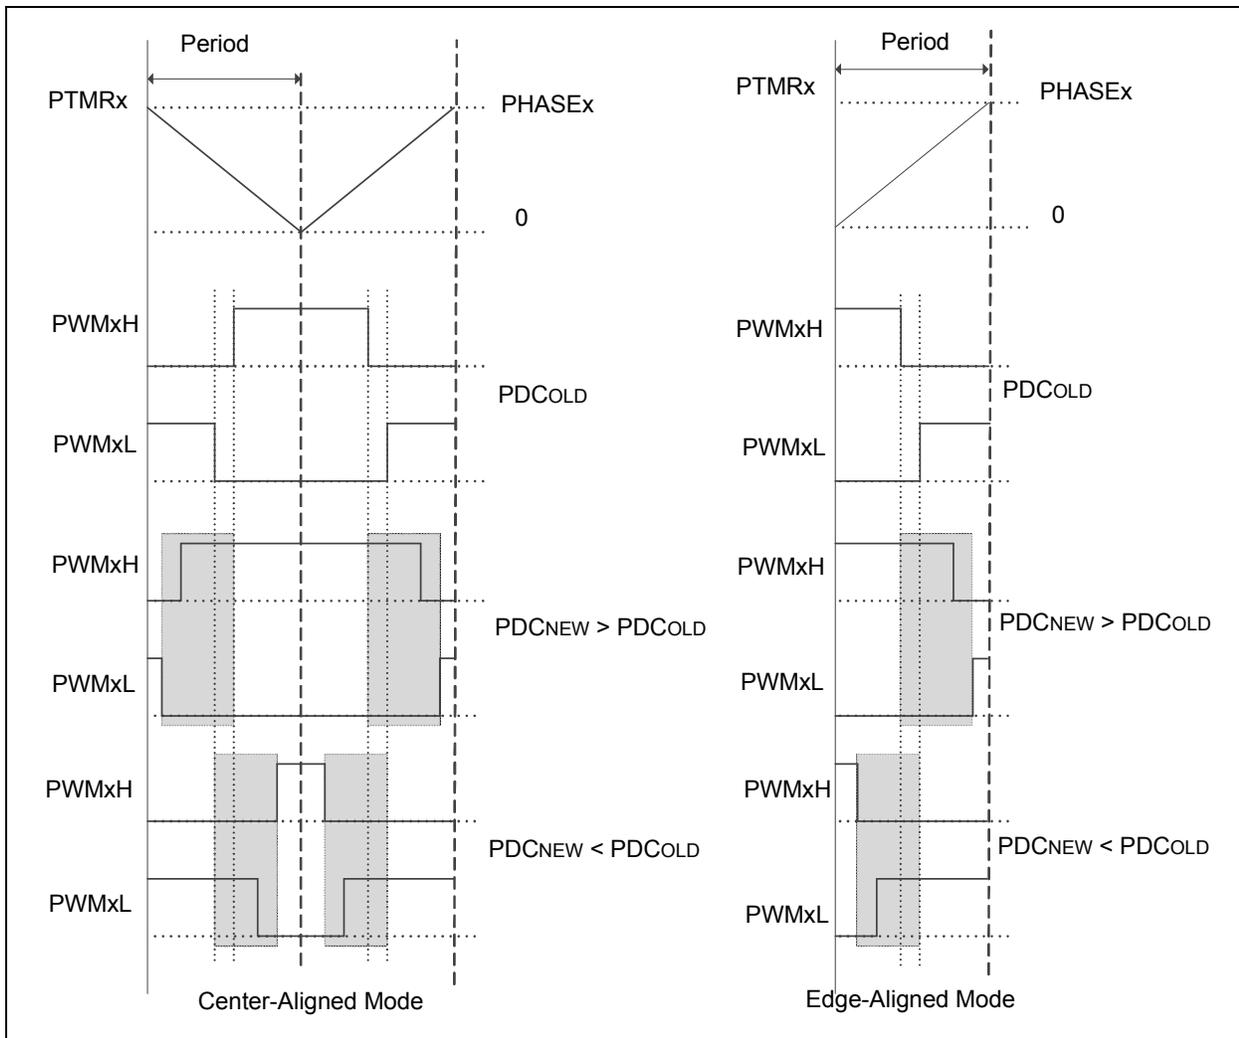
FIGURE 1: TIMING DIAGRAMS FOR CENTER-ALIGNED AND EDGE-ALIGNED MODES

The PWMx generator may not assert dead time on the edges of transitions. This has been observed when all of the following conditions are present:

The current duty cycle, PDCOLD, newly calculated duty cycle, PDCNEW, and the point at which the write to the Duty Cycle register occurs within the PWMx time base, will determine if the PWMxH and PWMxL outputs make an immediate transition. PWMxH and PWMxL outputs make an immediate transition if the Duty Cycle register is written with a new value, PDCNEW, at a point of time when the PWMx time base is

counting a value that is in between PDCNEW and PDCOLD. Additionally, writing to the Duty Cycle register close to the instant of time where dead time is being applied may result in reduced dead time, effective on the PWMxH and PWMxL transition edges.

In Figure 1, if the duty cycle write occurred in the shaded box, then PWMxH and PWMxL will make an immediate transition without dead time.

None. However, in most applications, the duty cycle update timing can be controlled using the TRIGx trigger or Special Event Trigger to avoid the above mentioned conditions.

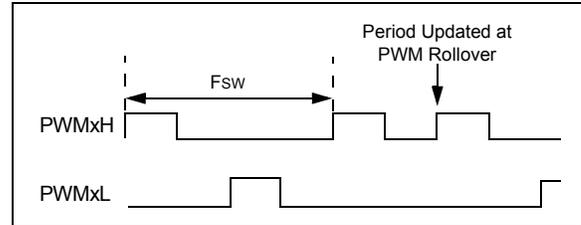
FIGURE 2:

When the PWM module is configured for Push-Pull mode (IOCONx<11:10> = 0b10) with the Enable Immediate Period Update bit enabled (PTCON <10> = 1), a write to the Period register that coincides with the period rollover event may cause the push-pull output logic to produce back-to-back pulses on the PWMx pins (see Figure 2).

Ensure that the update to the PWM Period register occurs away from the PWM rollover event by setting the EIPU bit (PTCON<10> = 1). Use either the PWM Special Event Trigger (SEVTCMP) or the PWM Primary Trigger (TRIGx) to generate a PWM Interrupt Service Routine (ISR) near the start of the PWM cycle. This ISR will ensure that period writes do not occur near the PWM period rollover event.

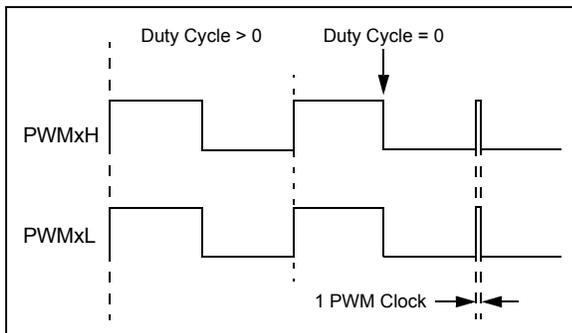
FIGURE 3: EXAMPLE FOR REDUNDANT OUTPUT MODE

In the Redundant Output mode (IOCONx<11:10> = 0b01) and Push-Pull Output mode (IOCONx<11:10> = 0b10), with the Immediate Update Enable bit disabled (PWMCONx<0> = 0), when the Duty Cycle register is updated from a non-zero value to zero, a glitch pulse of a width equal to 1 PWM clock will appear at the next PWM period boundary, as shown in Figure 3 (for the Redundant Output mode). The Duty Cycle register refers to the PDCx register if PWMCONx<8> = 0 or the MDC register if PWMCONx<8> = 1.

If the application requires a zero duty cycle output, there are two possible work around methods:

1. Use the PWM override feature to override the PWM output to a low state instead of writing to the Duty Cycle register. In order to switch back to a non-zero duty cycle output, turn off the PWM override. The override-on and override-off events must be timed close to the PWM period boundary if the IOCONx register has been configured with IOCONx<0> = 0 (i.e., output overrides through the OVRDAT<1:0> bits occur on the next CPU clock boundary).
2. Enable the Immediate Update Enable bit (PWMCONx<0> = 1) while configuring the PWMx module (i.e., before enabling the PWMx module, PTCON<15> = 1). With the Immediate Update enabled, writes to the Duty Cycle register can have an immediate effect on the PWM output. Therefore, the duty cycle write operations must be timed close to the PWM period boundary in order to avoid distortions in the PWM output.
